# Manhole Inspection Summary

Manhole # S21YY1002MH

Insp Date: **11/28/06 2:10 PM**

**Location** Address: **200 CROSS KEYS RD**

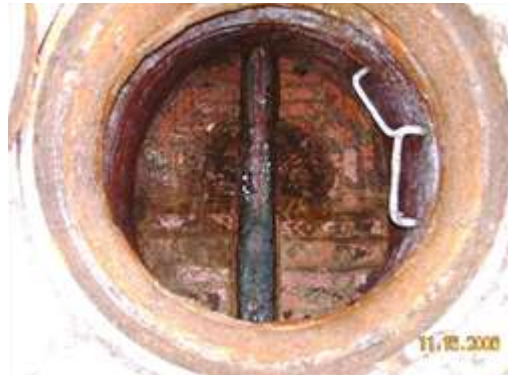
Top View

Frame leaks. Adjustment, Corbel and Barrel infiltration. Evidence of surcharge - Bench debris.

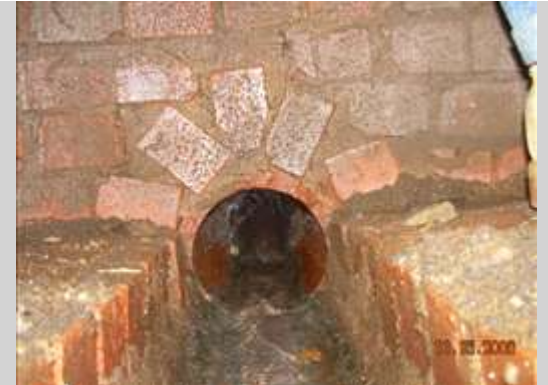
### 6 in. Circular Gravity Sewer Pipe Out @ 12 O'Clock

Deposits: ☐ None ☒ **Mud** ☐ Sludge ☐ Debris ☒ **Grease**

Silt Depth: **0** (in.) Deposits Extent: **Light**

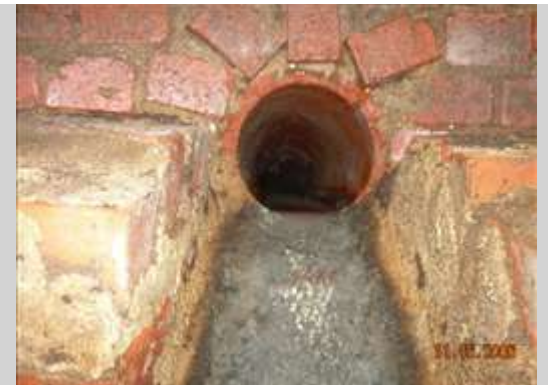
### 6 in. Circular Gravity Sewer Pipe In @ 6 O'Clock

Deposits: ☒ **None** ☐ Mud ☐ Sludge ☐ Debris ☐ Grease

Infiltration: **None** Pipe Seal Cond: **Unknown**
